**== USS STUMP (DD-978) ==**  
**SEMAT I SHELL CONDITION ASSESSMENT**  
**SURVEY**  
**INTERIOR AREAS**  
**11/26/01 TO 12/01/01 -- 12/17/01 TO 12/21/01**

Q.E.D. Systems, Inc. was tasked by the Supervisor of Shipbuilding Conversion and Repair, USN (SPORT) Portsmouth, VA to conduct an Ultrasonic Thickness (U/T) Survey of specific locations on board USS STUMP (DD-978) during the period of 26 November 2001 to 01 December 2001 / 17 December 2001 to 21 December 2001.

# USS STUMP (DD-978)

## SHELL CONDITION ASSESSMENT SURVEY INTERIOR AREAS TABLE OF CONTENTS

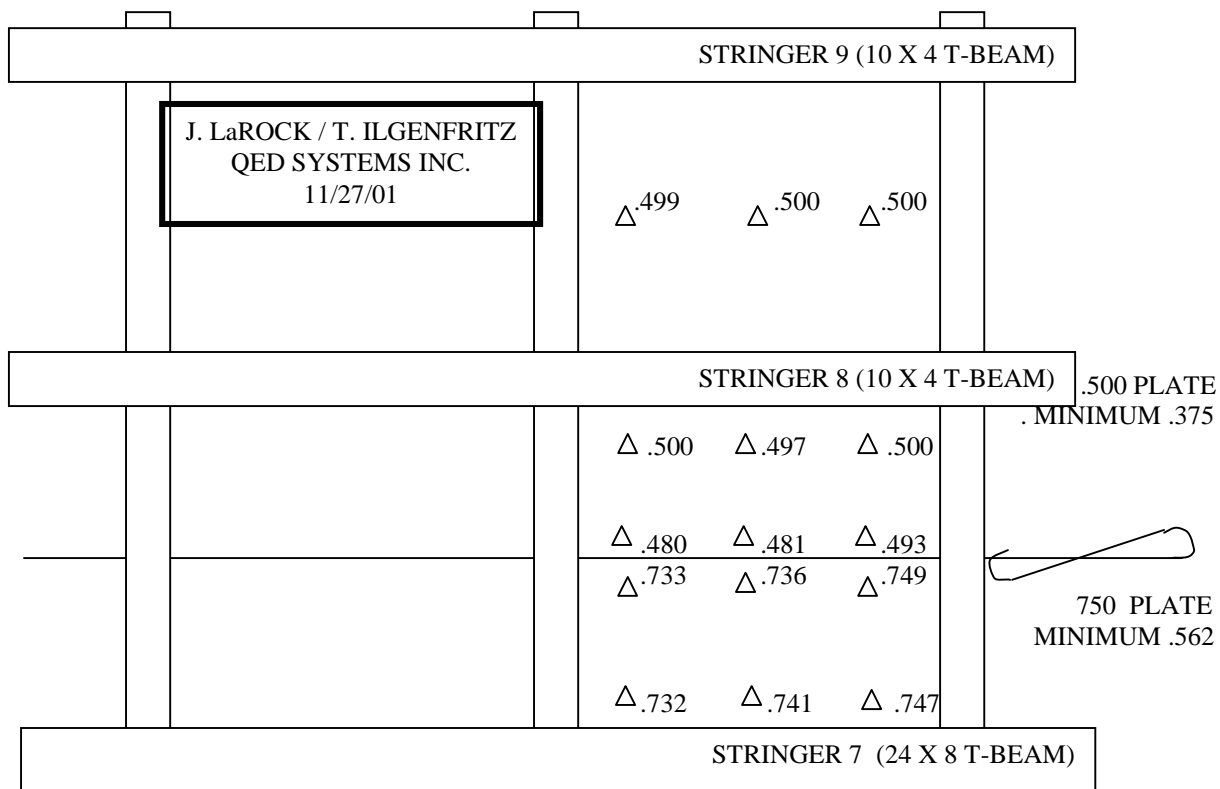
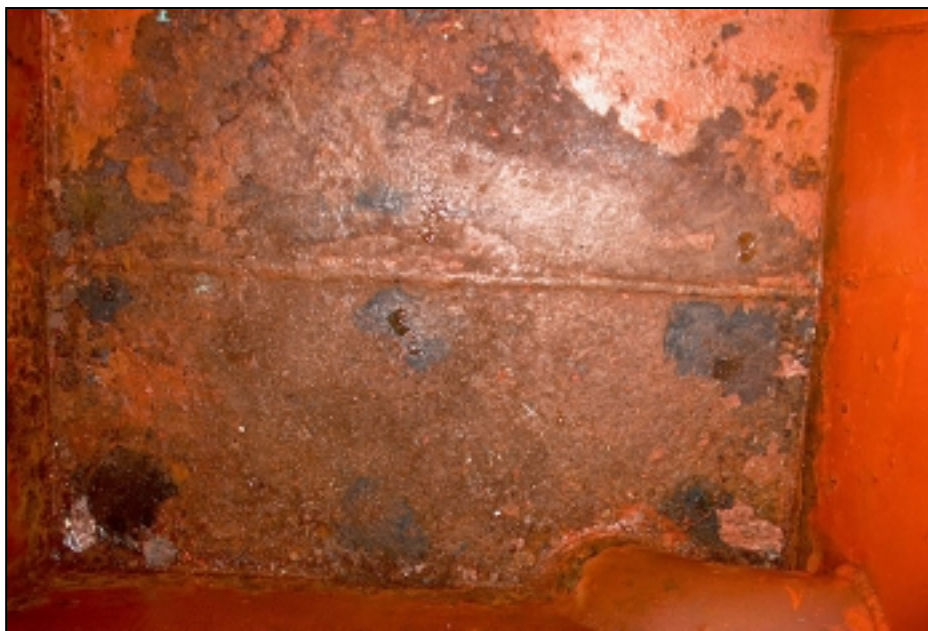
**USS STUMP (DD-978)**  
**STEERING GEAR ROOM ((6-506-0-E)**  
 STBD SIDE

SAFETY HAZARD: 1. SERIOUS - CORRECT AS SOON AS POSSIBLE 2. SERIOUS - SUSPENSION OF EQUIPMENT/SYSTEM/SPACE REQUIRED 3. SERIOUS - WAVIER OF EQUIPMENT/SYSTEM 4. SAFETY ITEM - MINOR 5. COMBUSTIBLE MATERIAL		1. MAINTENANCE ACTION COMPLETED: PARTS DRAWN FROM SUPPLY 2. MAINTENANCE ACTION COMPLETED: REQUIRED PARTS NOT DRAWN FROM SUPPLY 3. MAINTENANCE ACTION COMPLETED: NO PARTS REQUIRED 4. CANCELLED - DEFERRAL WILL BE REMOVED FROM CSMP 5. MAINTENANCE ACTION COMPLETED: 3-M CAPABILITY UTILIZED 6. NONE OF THE ABOVE, DESCRIBE IN REMARKS/DESCRIPTION SECTION			1. MANDATORY 2. ESSENTIAL 3. <b>HIGHLY DESIRABLE</b> 4. DESIRABLE
DISCREPANCY DESCRIPTION: PER SEMAT I UNDERWATER HULL ASSESSMENT: STBD SIDE (6-506-0-E) STEERING GEAR ROOM					
CORROSION WAS FOUND ON SHELL PLATE BETWEEN WEB FRAMES (509-512) AND STRINGERS (7-8). CAUSE FOR CORROSION					
IS SALT WATER EDUCTOR VALVE (3-510-1). U/T READINGS WERE SATISFACTORY SEE DRAWING.

SHELL PLATE BETWEEN WEB FRAMES (509-512)  
 AND STRINGERS (7-8) U/T READINGS WERE SATISFACTORY SEE DRAWING

APPROXIMATELY 12 SF.					
<b>RECOMMENDED REPAIRS:</b>					
RECOMMEND SHIPS FORCE CLEAN TO BARE METAL APPROXIMATELY 12 SF, PRIME AND PAINT. FIX LEAKING VALVE.					
SSPORT C221 POC: J. BRUCKNER (757) 396-4001 EXT 2186, TPOC: J. LaROCK QED SYSTEMS INC. (757) 490-5047					
CSMP SUMMARY: SHELL PLATE CORRODED BETWEEN WF (509-512)				TEST# MRC 1102/1	
ROOT CAUSE/AMPLIFICATION: H1				STEP# 1,2,3,4 & 5	
SYSTEM LEVEL IMPACT:					
PART NO.	NOMEMCLATURE		QTY	NSN	COST
1					
2					
3					
4					
5					
6					
FIRST CONTACT <b>TOMS</b>	RATE MR2	SECOND CONTACT <b>BEARDEN</b>		RATE HT2	PHONE
ASSESSOR / ACT / TECH ID# J. LaROCK/ T. ILGENFRITZ QED SYSTEMS INC.			TD	TL	LOGISTICIAN
					TSP

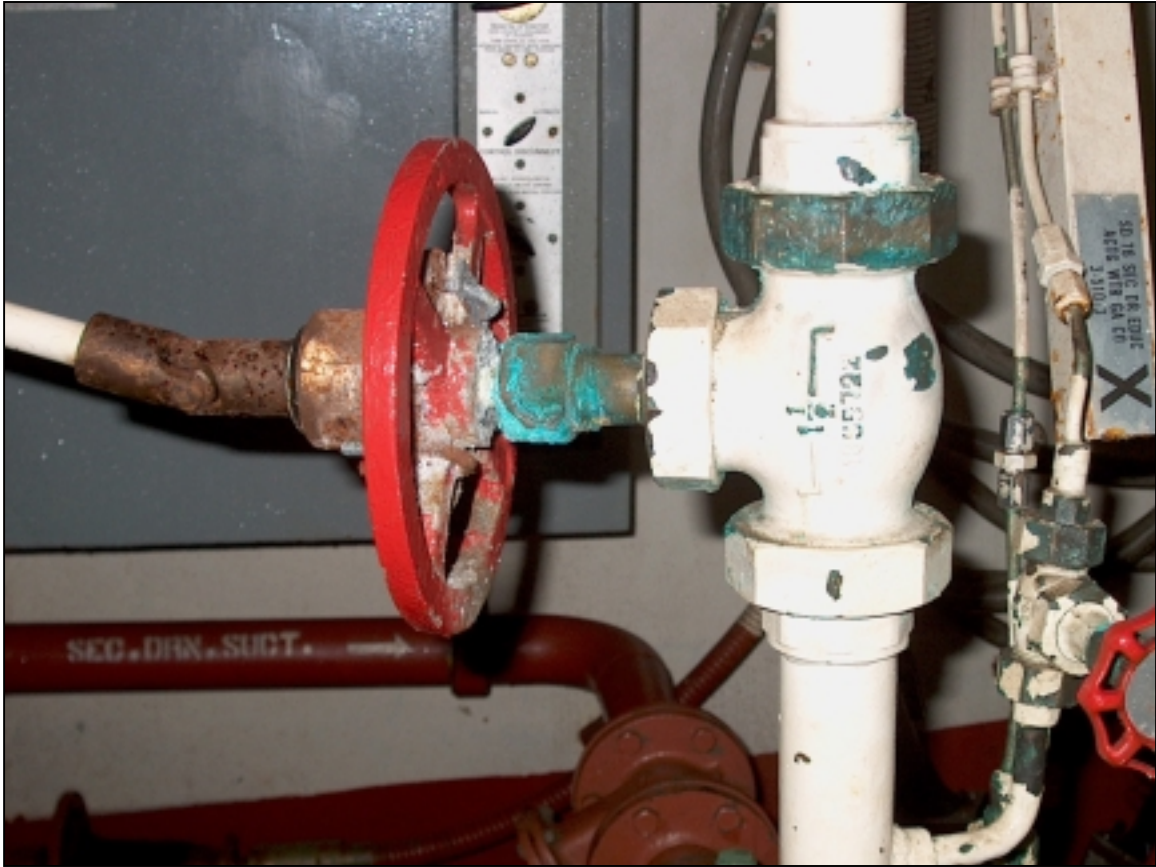
SALT WATER EDUCTOR VALVE (3-510-1) ROOT CAUSE OF CORROSION ON SHELL PLATE.

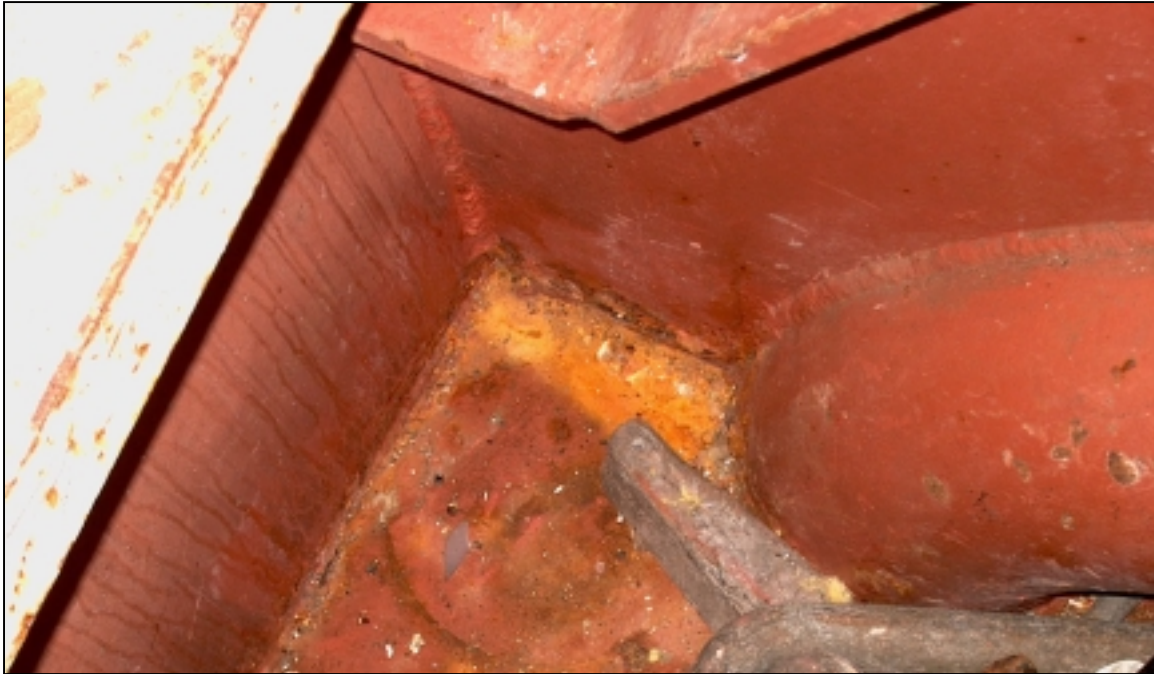
SSPORT C221 POC: J. BRUCKNER (757) 396-4001 EXT 2186, TPOC: J. LaROCK QED SYSTEMS INC. (757) 490-5047					
<b>CSMP SUMMARY:</b> ENTIRE BILGE AREA HAS SURFACE RUST AND PAINT FAILURE. LADDER RUNG IS MISSING				TEST# MRC 1102/1	
ROOT CAUSE/AMPLIFICATION: H1				STEP# 1,2,3,4 & 5	
SYSTEM LEVEL IMPACT:					
PART NO.	NOMENCLATURE		QTY	NSN	COST
1					
2					
3					
4					
5					
6					
FIRST CONTACT <b>TOMS</b>	RATE MR2	SECOND CONTACT <b>BEARDEN</b>		RATE HT2	PHONE
ASSESSOR / ACT / TECH ID# J. LaROCK/ T. ILGENFRITZ QED SYSTEMS INC.			TD	TL	LOGISTICIAN TSP

CORROSION ON SHELL PLATE FORWARD OF BHD (506)

SAFETY HAZARD: 1. SERIOUS - CORRECT AS SOON AS POSSIBLE 2. SERIOUS - SUSPENSION OF EQUIPMENT/SYSTEM/SPACE REQUIRED 3. SERIOUS - WAIVER OF EQUIPMENT/SYSTEM 4. SAFETY ITEM - MINOR 5. COMBUSTIBLE MATERIAL		1. MAINTENANCE ACTION COMPLETED: PARTS DRAWN FROM SUPPLY 2. MAINTENANCE ACTION COMPLETED: REQUIRED PARTS NOT DRAWN FROM SUPPLY 3. MAINTENANCE ACTION COMPLETED: NO PARTS REQUIRED 4. CANCELLED DEFERRAL WILL BE REMOVED FROM CSMP 5. MAINTENANCE ACTION COMPLETED: S-MCA ABILITY UTILIZED 6. NONE OF THE ABOVE DESCRIBE WHEN REMOVED/DEFERRATION SECURED			1. MANDATORY 2. ESSENTIAL 3. <b>HIGHLY DESIRABLE</b> 4. DESIRABLE
DISCREPANCY DESCRIPTION: PER SEMAT I UNDERWATER HULL ASSESSMENT: STBD SIDE, (6-488-3-A) REEL STOREROOM NO. 1					
APPROXIMATELY 80 SF OF SURFACE RUST AND PAINT SEPARATION BOTTOM LADDER RUNG IS MISSING.					
RECOMMENDED REPAIRS: RECOMMEND SHIPS FORCE CLEAN APPROXIMATELY 80 SF TO BARE METAL PRIME AND PAINT AREA. RECOMMEND REPLACING LADDER.

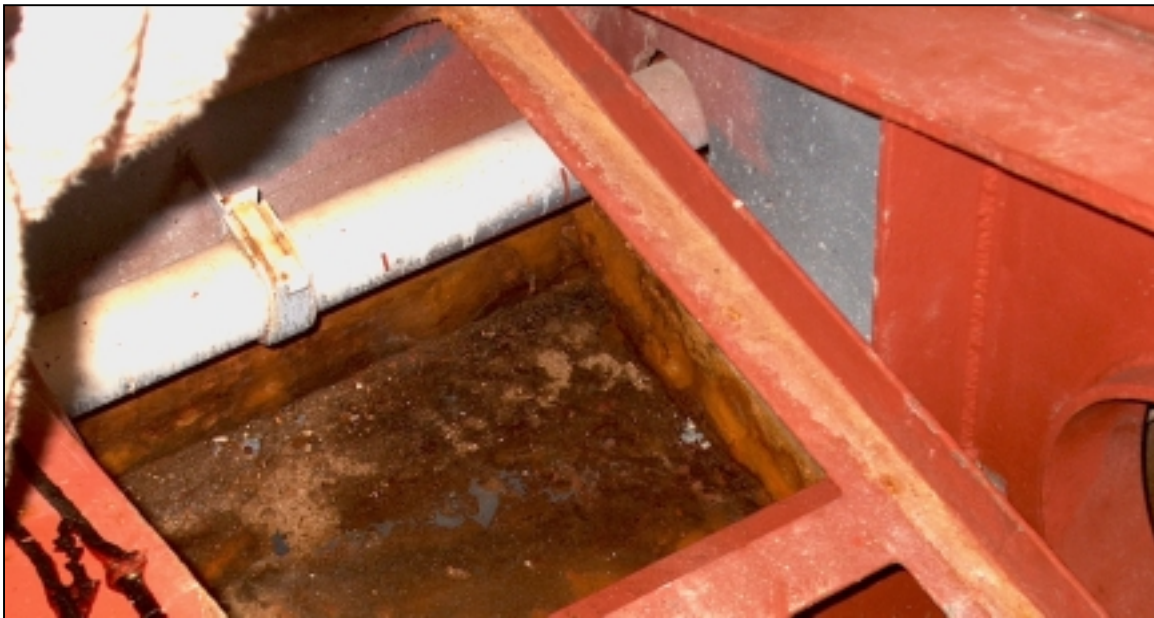
CORROSION ON SHELL PLATE AT WEB FRAME (494)

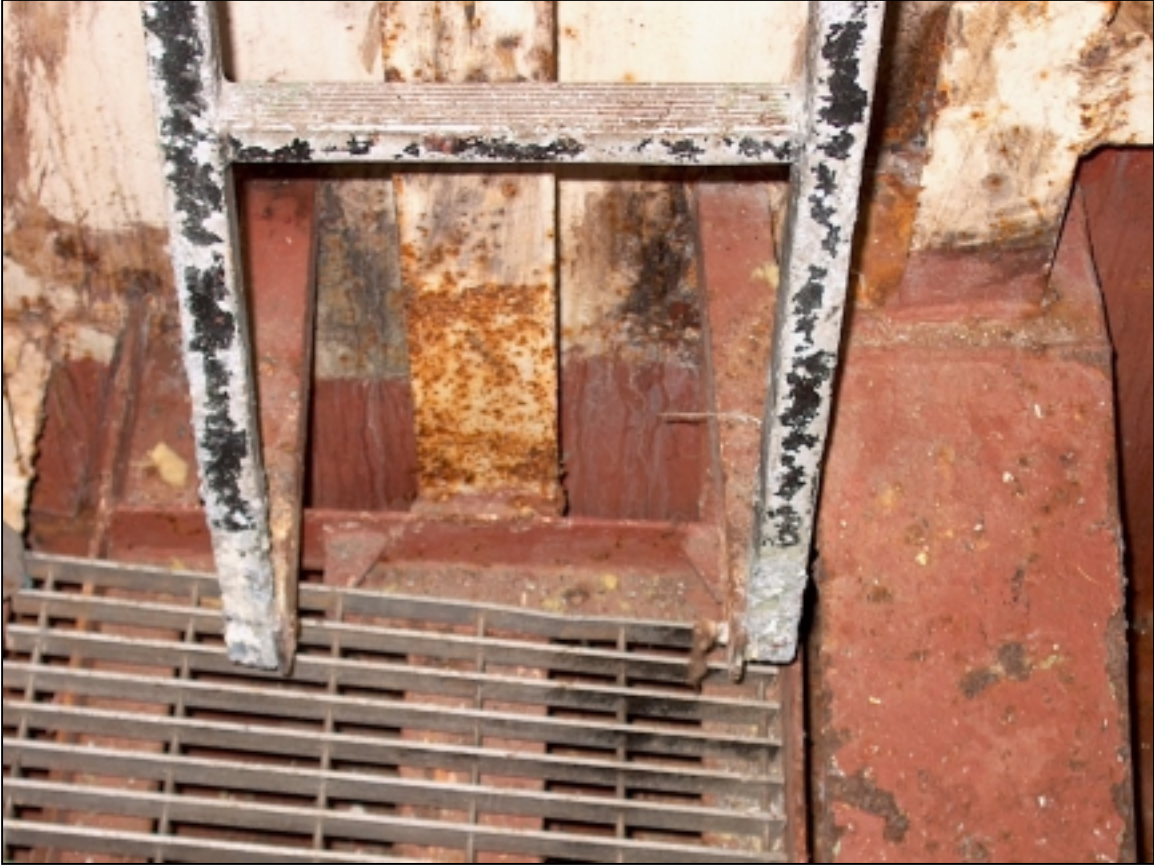
BOTTOM LADDER RUNG IS MISSING.

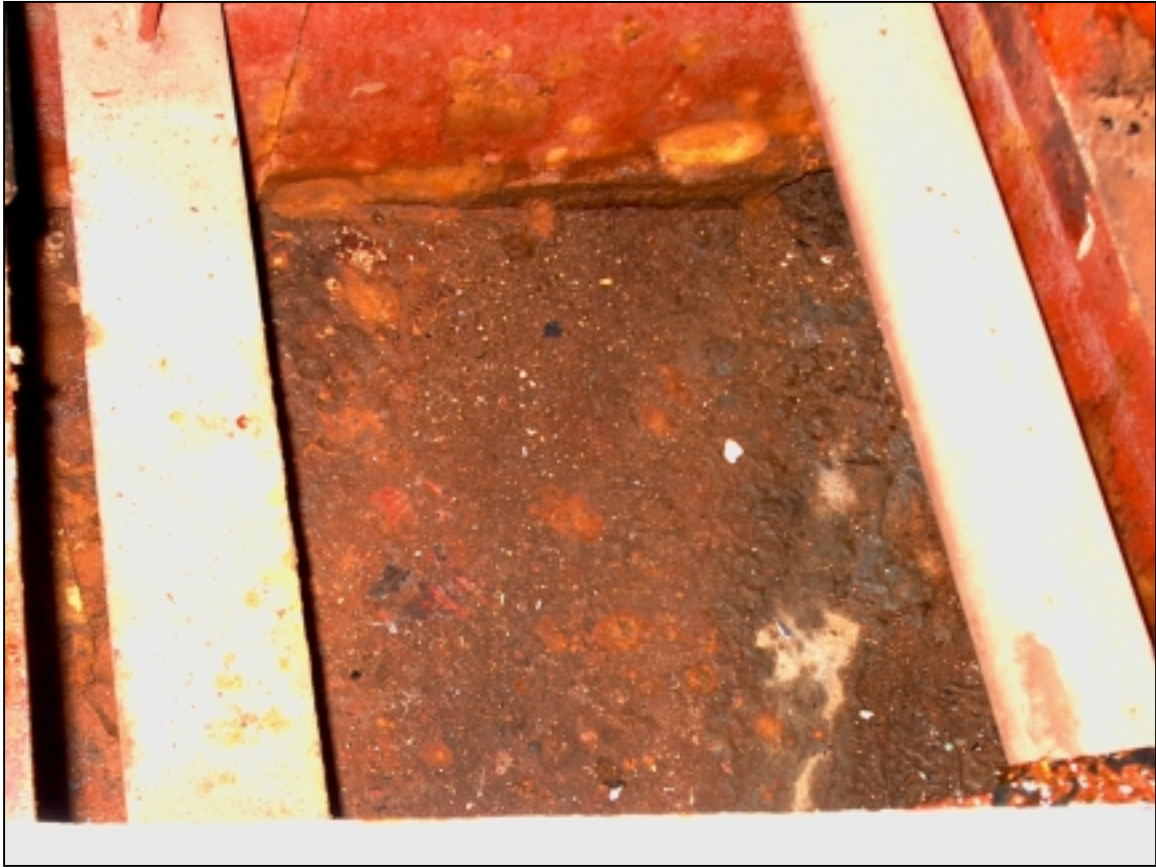
SSPORT C221 POC: J. BRUCKNER (757) 396-4001 EXT 2186, TPOC: J. LaROCK QED SYSTEMS INC. (757) 490-5047					
CSMP SUMMARY: TRAPPED SEWAGE/ WATER/CORROSION IN BILGE				TEST# MRC 1102/1	
ROOT CAUSE/AMPLIFICATION: H1				STEP# 1,2,3,4 & 5	
SYSTEM LEVEL IMPACT:					
PART NO.	NOMENCLATURE		QTY	NSN	COST
1					
2					
3					
4					
5					
6					
FIRST CONTACT TOMS	RATE MR2	SECOND CONTACT BEARDEN		RATE HT2	PHONE
ASSESSOR / ACT / TECH ID# J. LaROCK/ T. ILGENFRITZ QED SYSTEMS INC.			TD	TL	LOGISTICIAN TSP

SHELL PLATE FORWARD OF BHD (480)  
CSMP / JSN-0199

SAFETY HAZARD: 1. SERIOUS - CORRECT AS SOON AS POSSIBLE 2. SERIOUS - SUSPENSION OF EQUIPMENT/SYSTEM/SPACE REQUIRED 3. SERIOUS - WAIVER OF EQUIPMENT/SYSTEM 4. SAFETY ITEM - MINOR 5. COMBUSTIBLE MATERIAL		1. MAINTENANCE ACTION COMPLETED: PARTS DRAWN FROM SUPPLY 2. MAINTENANCE ACTION COMPLETED: REQUIRED PARTS NOT DRAWN FROM SUPPLY 3. MAINTENANCE ACTION COMPLETED: NO PARTS REQUIRED 4. CANCELLED - DEFERRAL WILL BE REMOVED FROM CSMP 5. MAINTENANCE ACTION COMPLETED: 3-M CAPABILITY UTILIZED 6. NONE OF THE ABOVE, DESCRIBE IN REMARKS/DESCRIPTION SECTION			1. MANDATORY 2. ESSENTIAL 3. <b>HIGHLY DESIRABLE</b> 4. DESIRABLE
DISCREPANCY DESCRIPTION: PER SEMAT I UNDERWATER HULL ASSESSMENT: 6-476-1-A SPECIAL CLOTHING ISSUE STOREROOM					
ENTIRE BILGE HAS HEAVY PAINT SEPARATION . SEWAGE WATER IS TRAPPED IN VARIOUS POCKETS. UNABLE TO PERFORM U/T SURVEY DUE TO SEWAGE IN THE BILGE. APPROXIMATELY 60 SF					
RECOMMENDED REPAIRS: RECOMMEND SHIPS FORCE REMOVE SEWAGE/WATER FROM BILGE, CLEAN ENTIRE AREA TO BARE METAL PRIME AND PAINT.

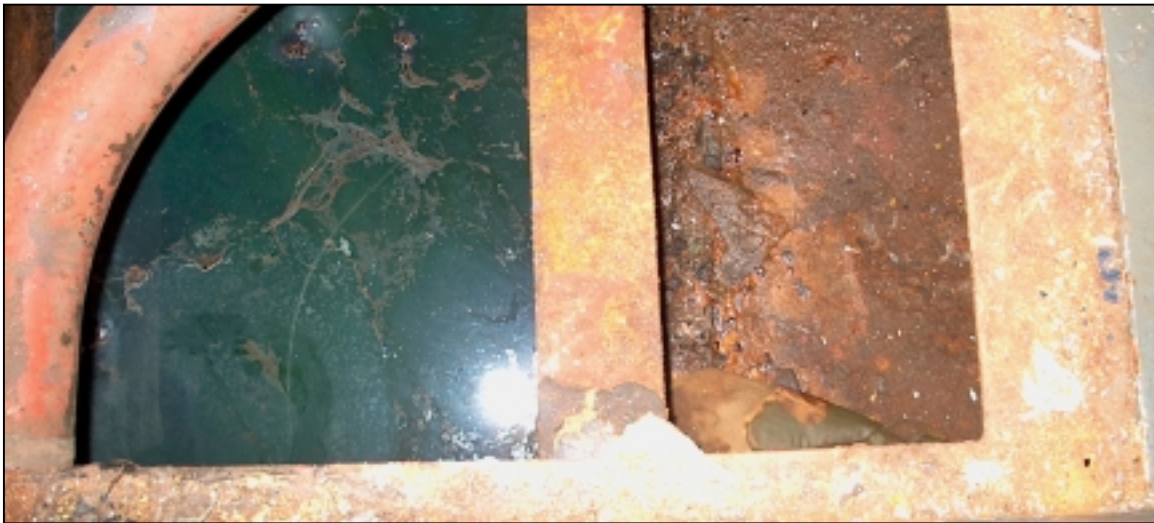
SEWAGE/WATER TRAPPED IN BILGE AFT OF BHD 476

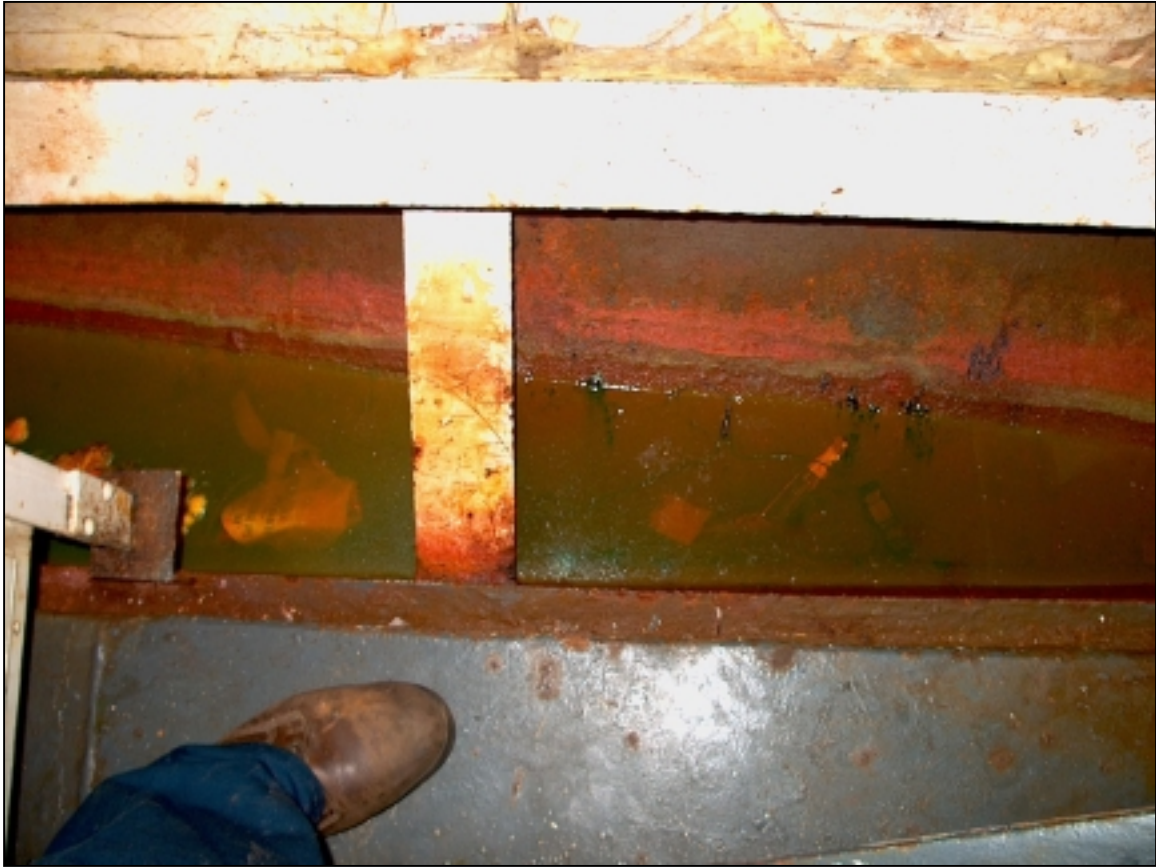
WATER TRAPPED IN BILGE POCKET.  
CSMP / JSN-0199

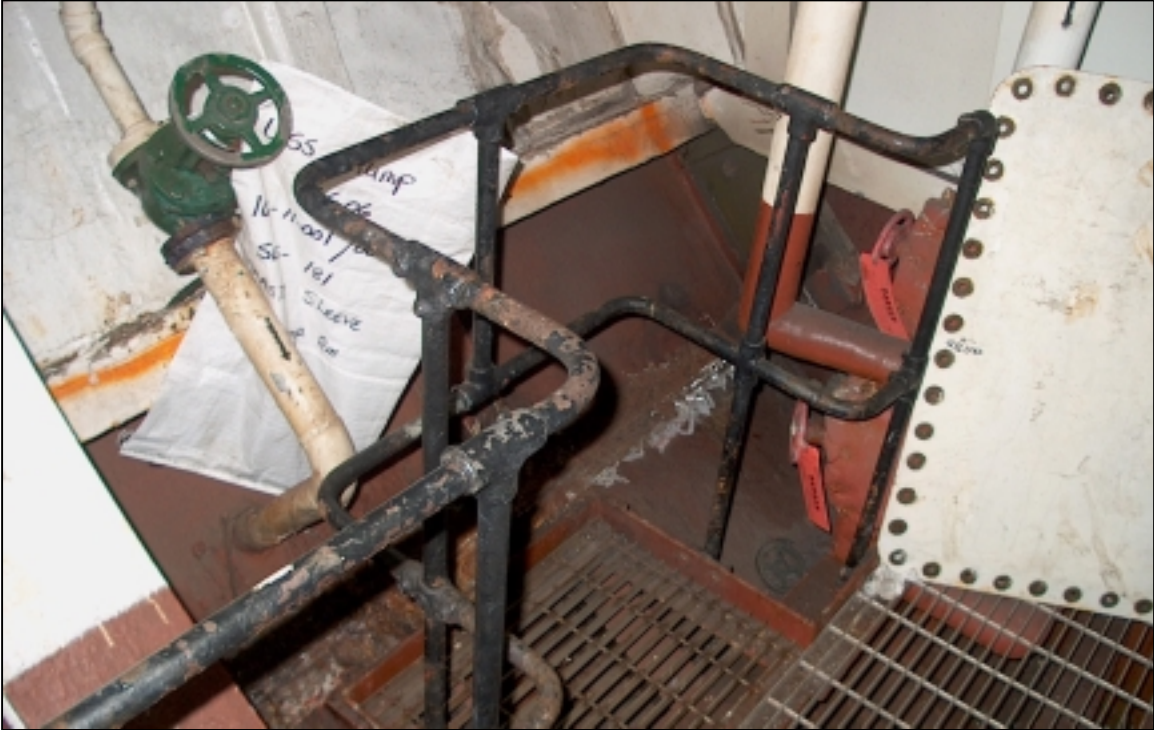
STRINGER REPAIRS ARE IN PROGRESS IN THIS AREA.  
(CSMP / JSN – P019)

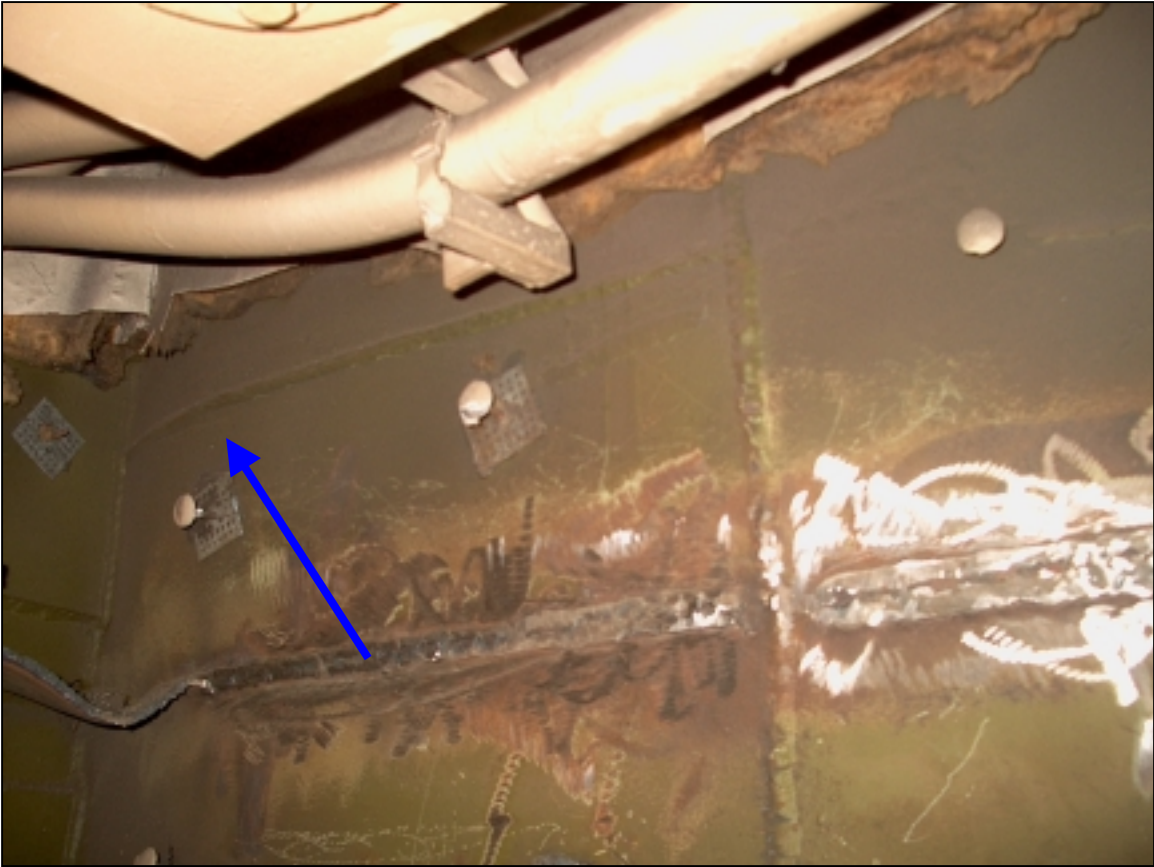
5<sup>TH</sup> STRINGER UP FROM MARGIN PLATE IS REMOVED, NOTE BUCKLE IN SHELL PLATE.  
(CSMP / JSN P019)

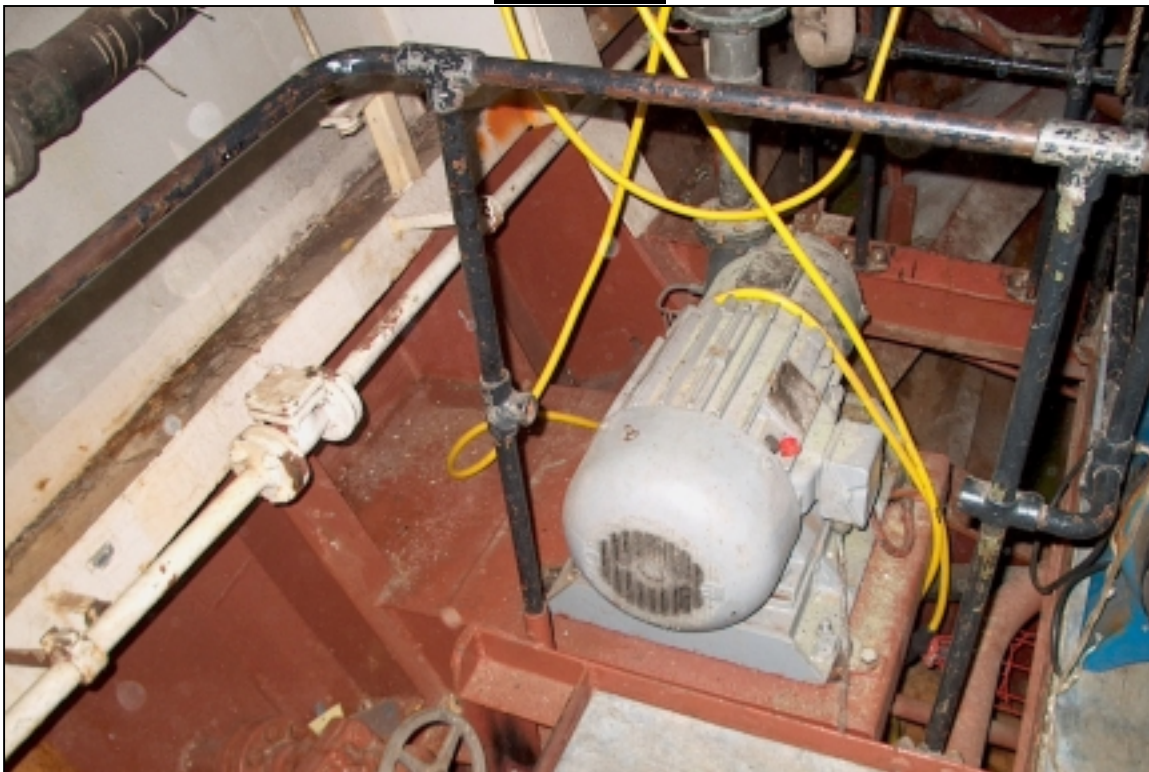
SEA WATER COOLING PUMP FOR NO. 2 GAS TURBINE GENERATOR  
(CSMP / JSN – 0120)

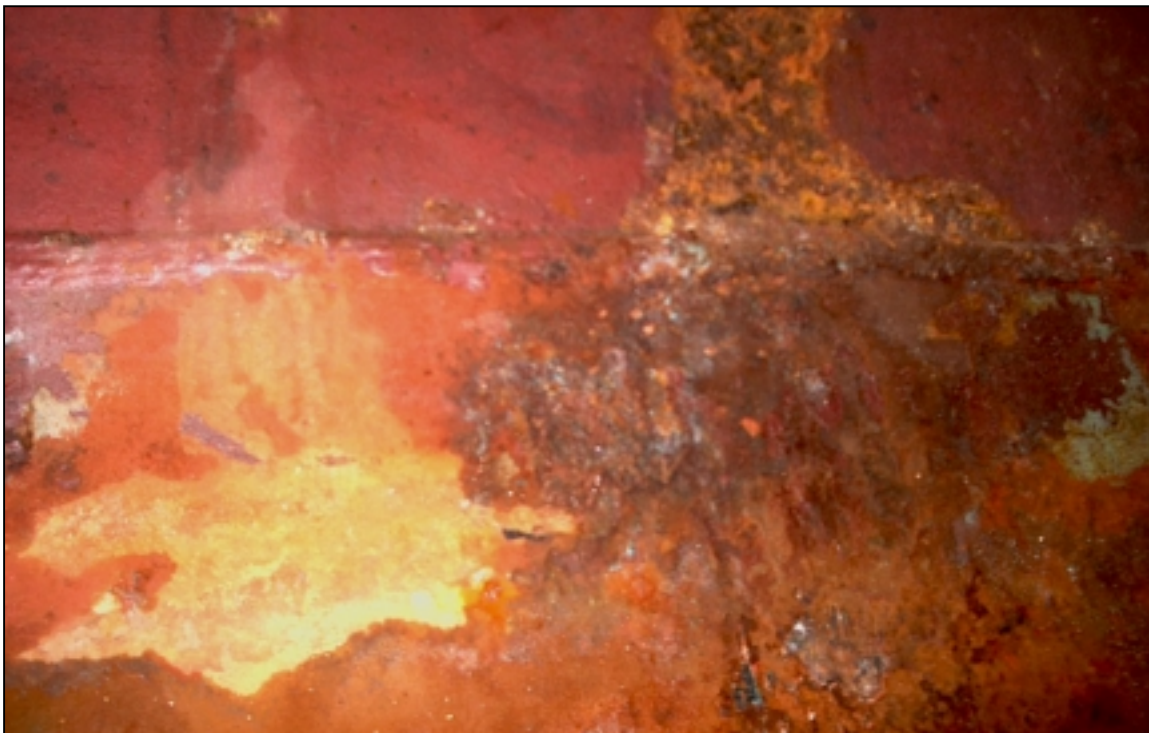
SHELL PLATE UNDERNEATH FOUNDATION FOR SEA WATER COOLING PUMP

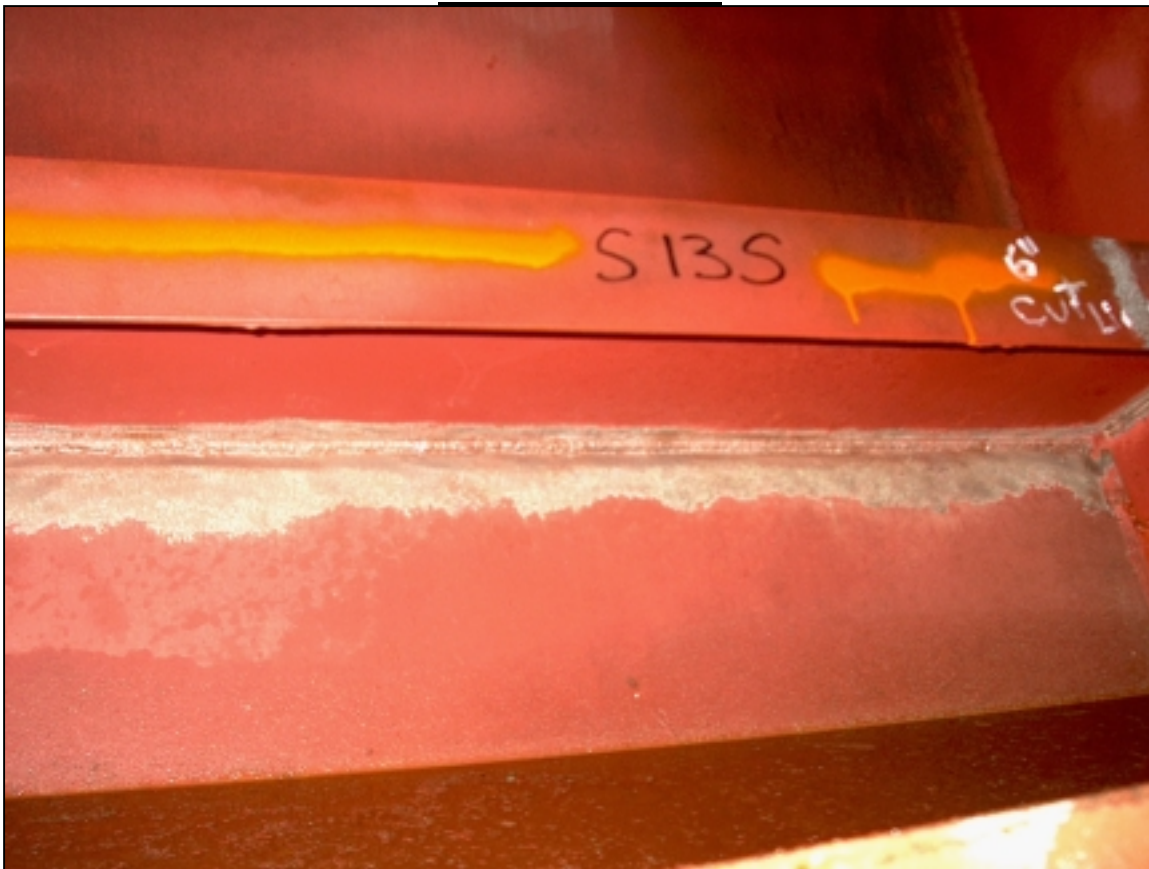
REPLACEMENT OF 3<sup>RD</sup> STRINGER FROM MARGIN PLATE BETWEEN WEB FRAME (308-316).  
(CSMP / JSN – A305)

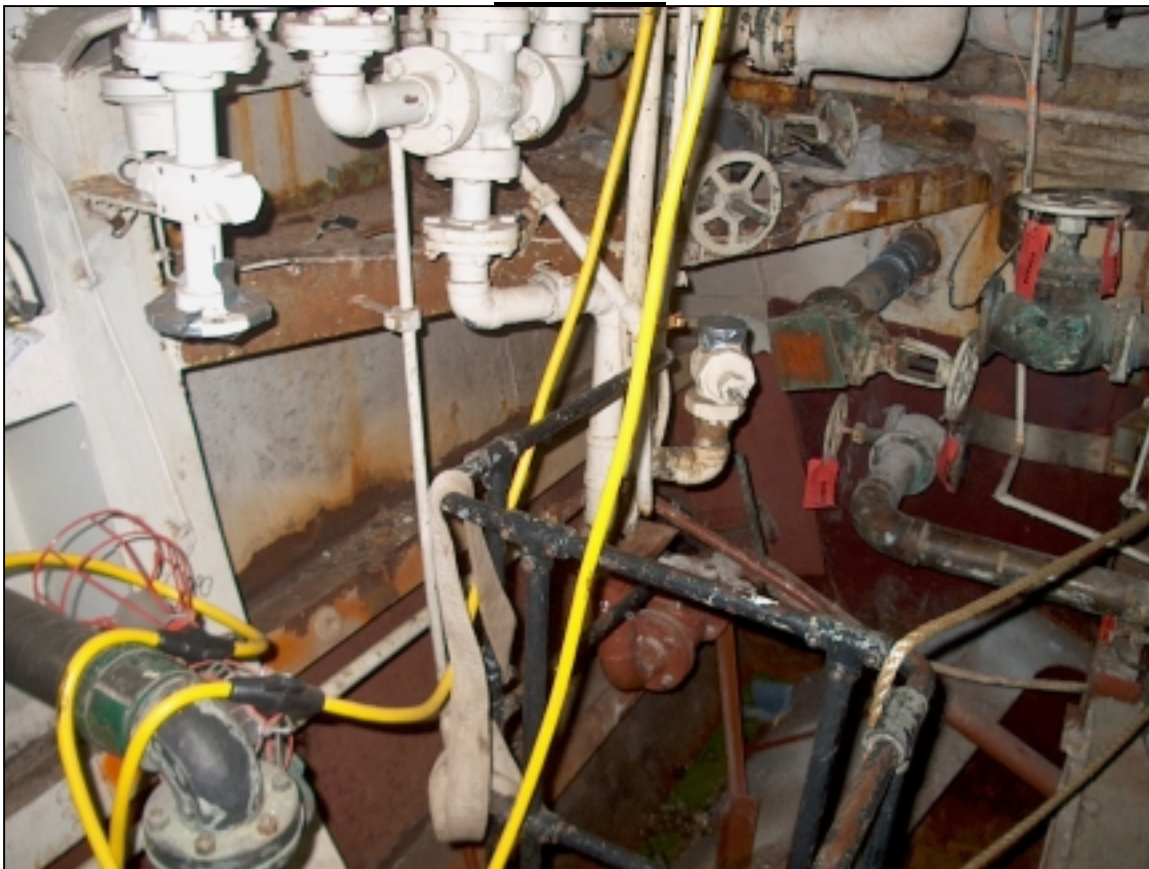
“CONDENSATE CORNER”  
THIS AREA IS HISTORICALLY PRONE TO CORROSION ON THE (DD-963) CLASS  
REPAIRS ARE IN PROGRESS (CSMP / JSN-A306)

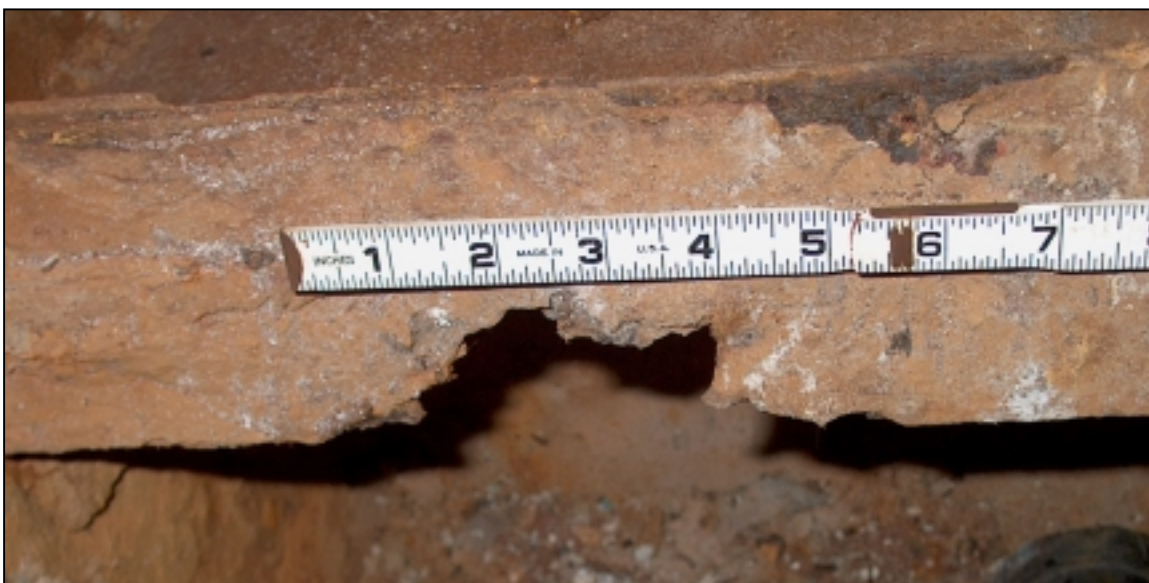
FIRST STRINGER FROM MARGIN PLATE AT WEB FRAME (308)

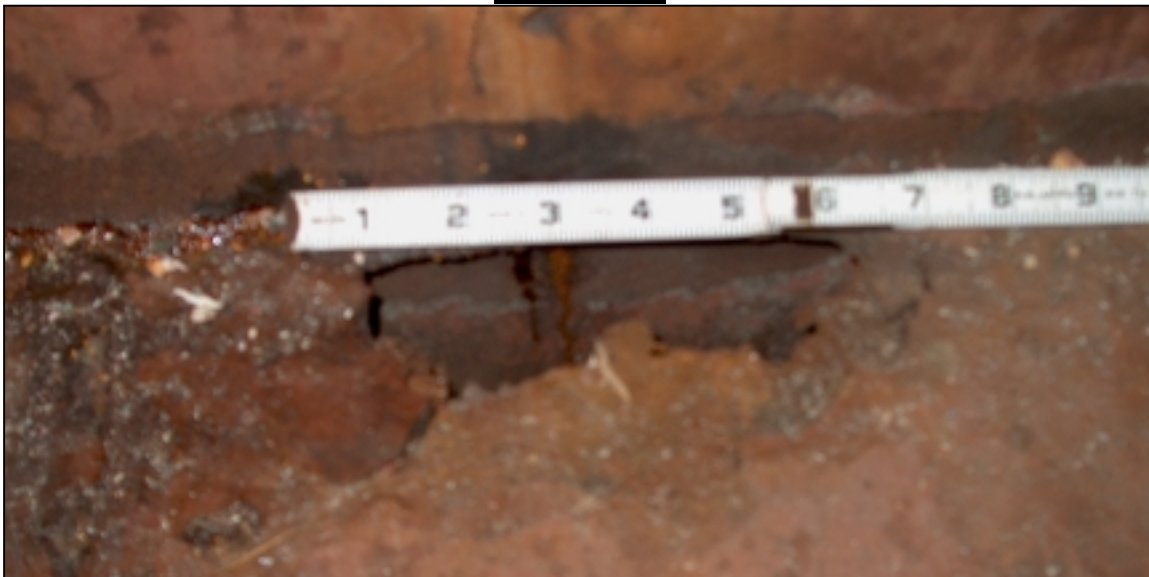
HOLE IN WEB OF 4<sup>TH</sup> STRINGER FROM MARGIN PLATE APPROXIMATELY 2'  
FORWARD OF WEB FRAME (308) (CSMP / JSN – A306)

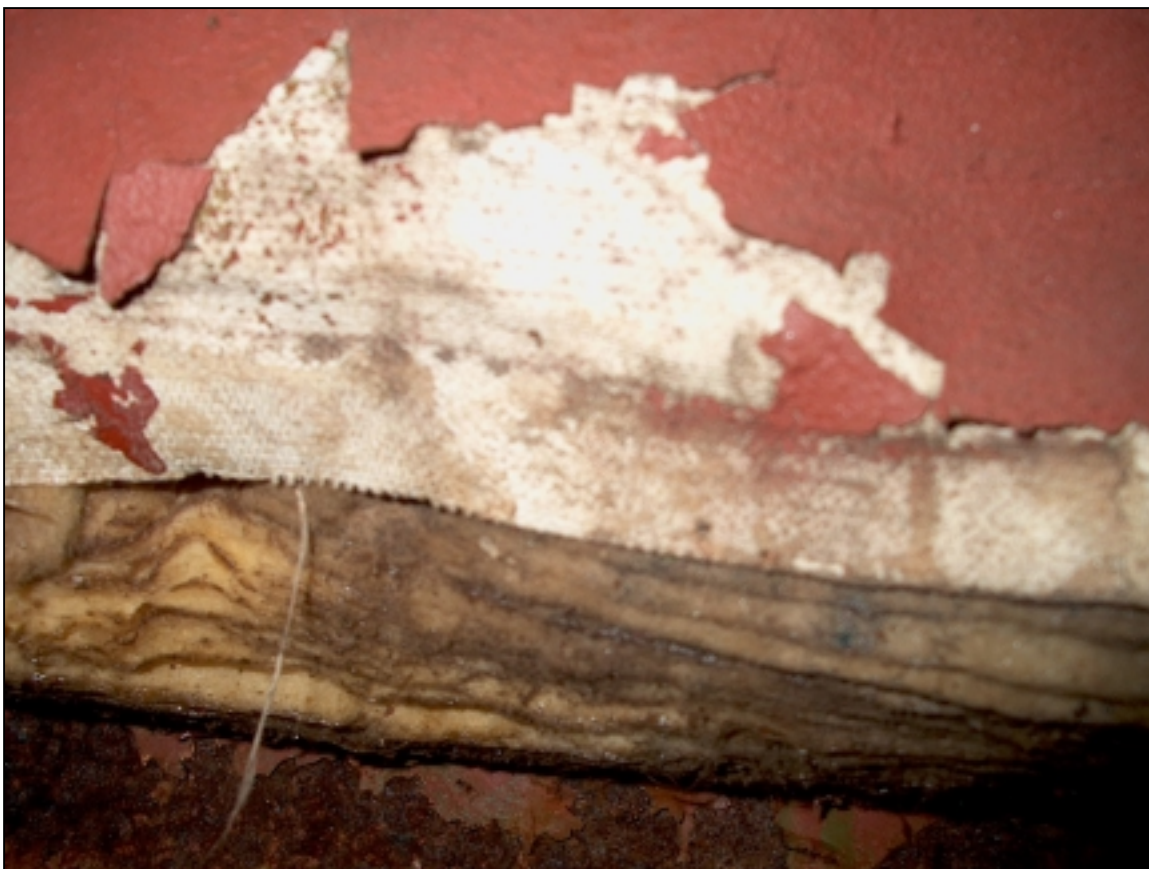
DAMAGED LAGGING ON BHD (346)

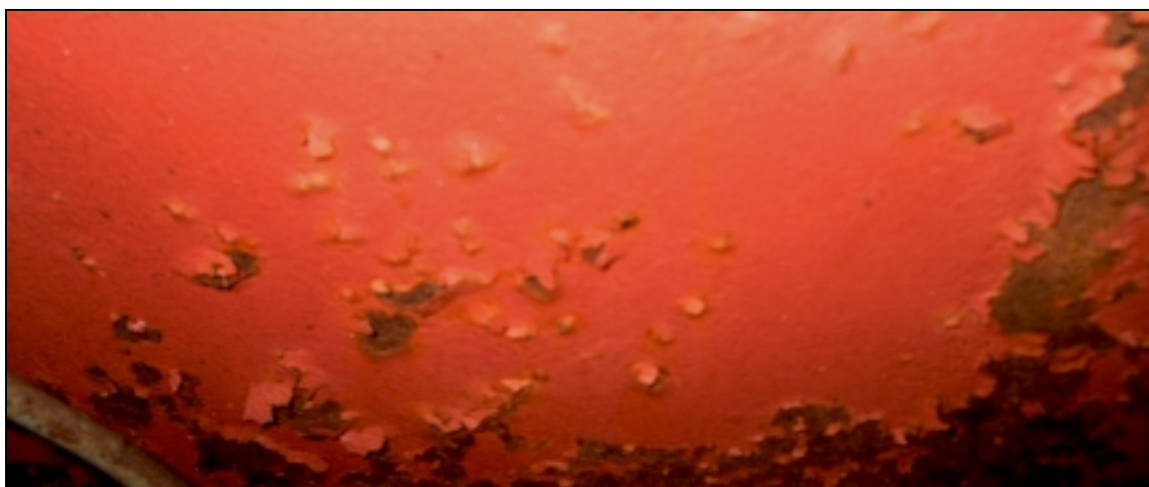
TYPICAL VIEW OF BHD (346) AT DECK PLATE LEVEL (CSMP-JSN-Y013)

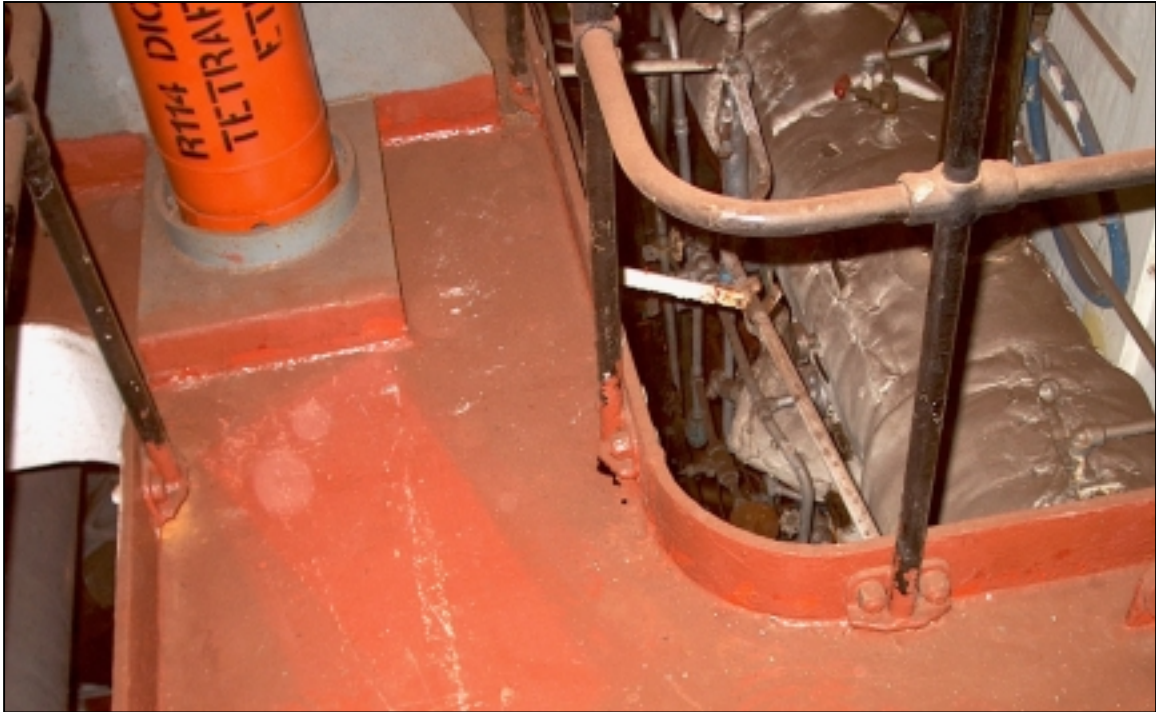
HOLE IN DECK UPPER LEVEL APPROXIMATELY 10 FT PORT OF CENTER LINE  
(CSMP / JSN -P014)

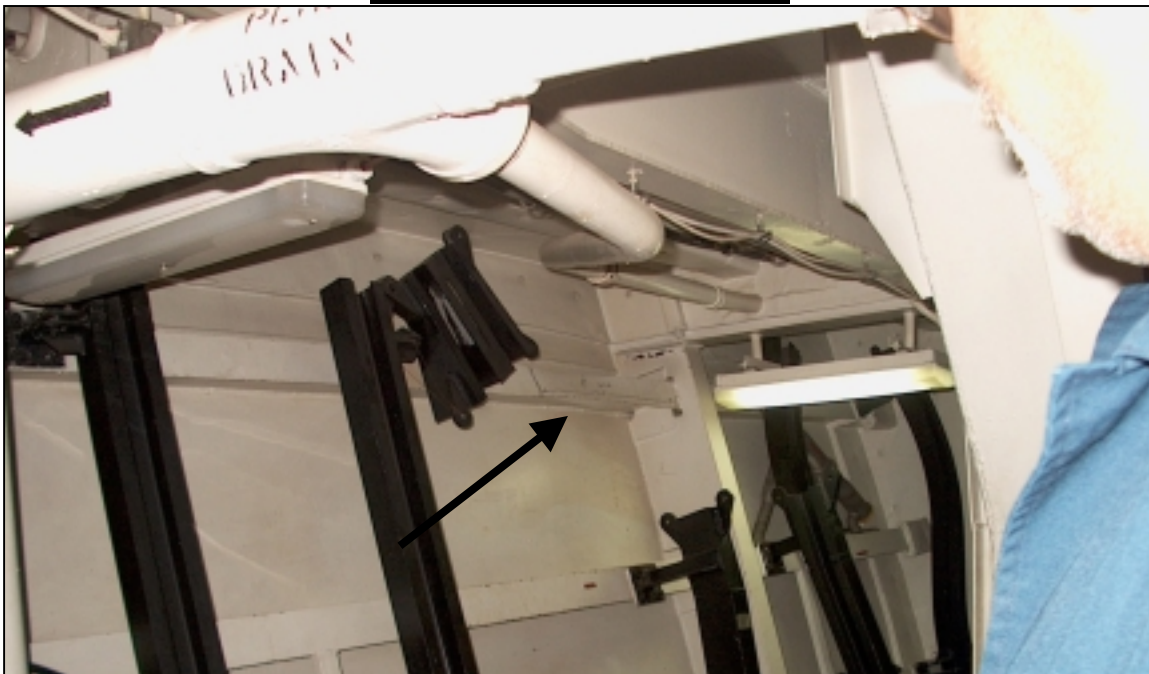
4<sup>TH</sup> STRINGER UP FROM UPPER LEVEL DECK AT WEB FRAME (180)  
(CSMP / JSN-A256)

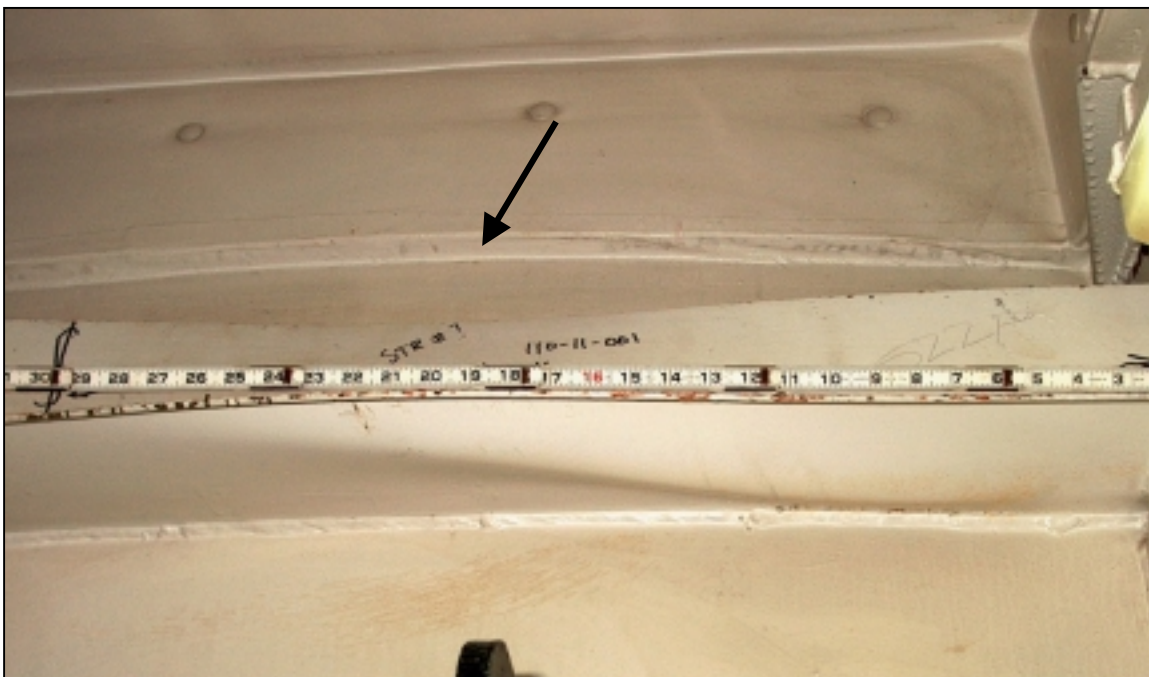
NOTE BUCKLE IN SHELL PLATING

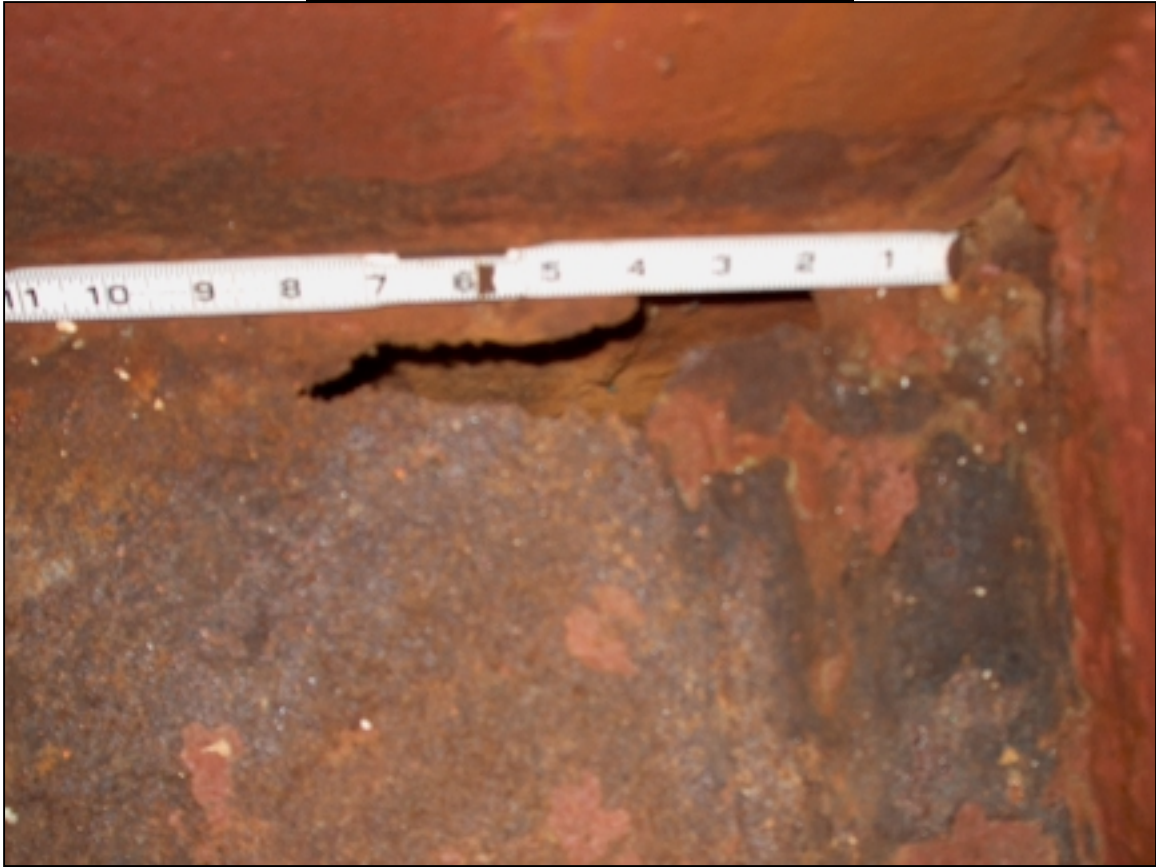
1<sup>ST</sup> STRINGER FROM MARGIN PLATE AT BHD (220) CSMP (JSN – A255)

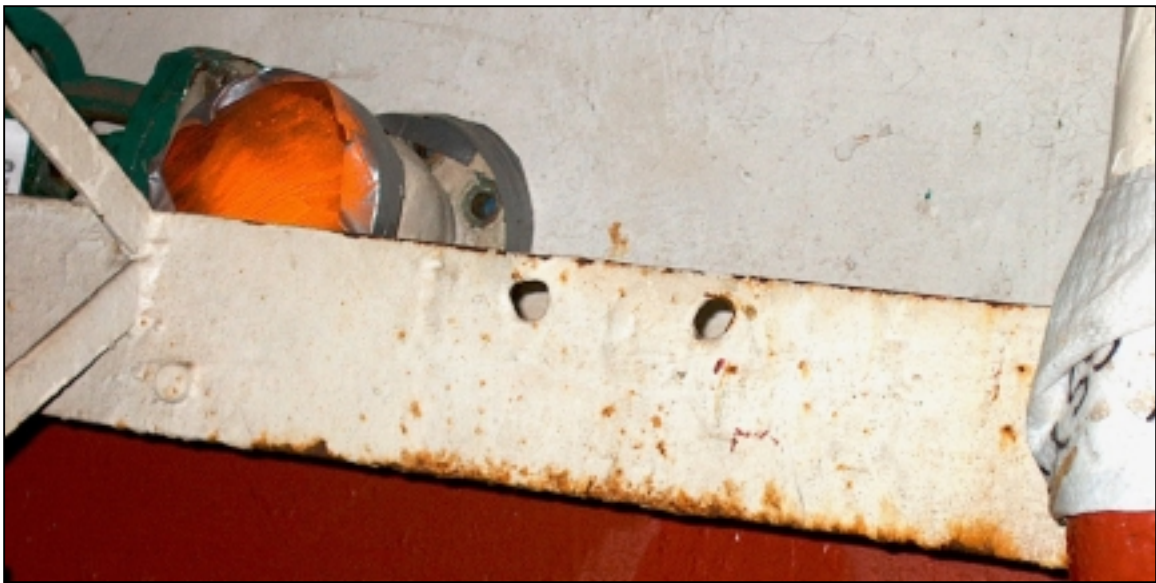
HOLES IN FLANGE OF STRINGER AT WEB FRAME (212) (CSMP / JSN – A257)

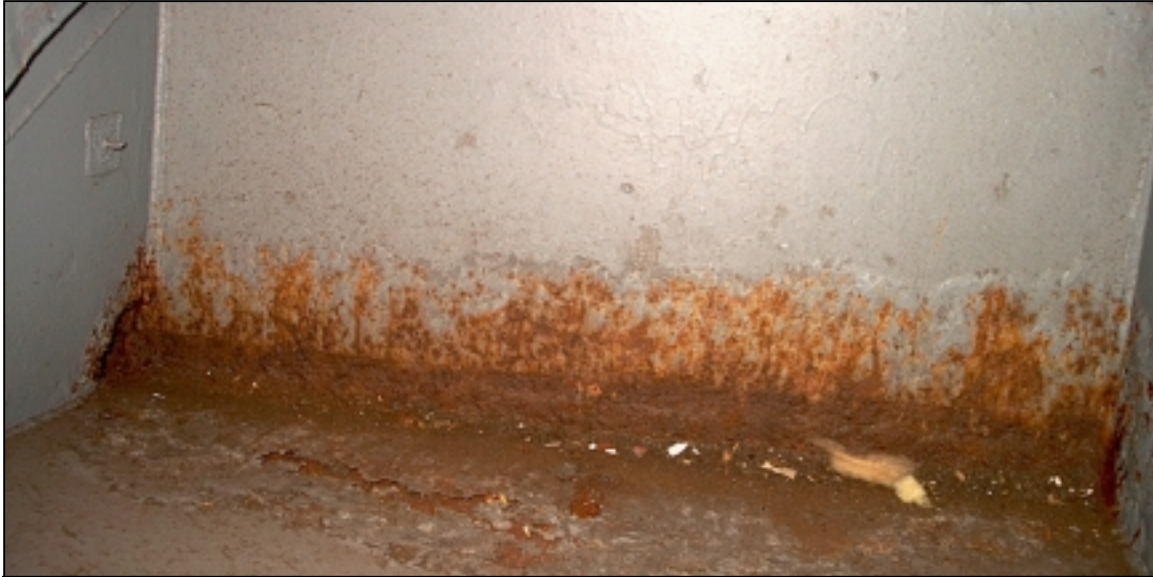
SAFETY HAZARD: 1. SERIOUS - CORRECT AS SOON AS POSSIBLE 2. SERIOUS - SUSPENSION OF EQUIPMENT/SYSTEM/SPACE REQUIRED 3. SERIOUS - WAIVER OF EQUIPMENT/SYSTEM 4. SAFETY ITEM - MINOR 5. COMBUSTIBLE MATERIAL		1. MAINTENANCE ACTION COMPLETED: PARTS DRAWN FROM SUPPLY 2. MAINTENANCE ACTION COMPLETED: REQUIRED PARTS NOT DRAWN FROM SUPPLY 3. MAINTENANCE ACTION COMPLETED: NO PARTS REQUIRED 4. CANCELLED - DEFERRAL WILL BE REMOVED FROM CSMP 5. MAINTENANCE ACTION COMPLETED: 3-M CAPABILITY UTILIZED 6. NONE OF THE ABOVE, DESCRIBE IN REMARKS/DESCRIPTION SECTION			1. MANDATORY 2. ESSENTIAL 3. <b>HIGHLY DESIRABLE</b> 4. DESIRABLE
<b>DISCREPANCY DESCRIPTION: PER SEMAT I UNDERWATER HULL ASSESSMENT: SMALL ARMS MAGAZINE (3-437-2-M) BILGE POCKET</b>					
BILGE POCKET AT BHD (437) AND BETWEEN WEB FRAMES (448-452) HAS RUST, HEAVY PAINT SEPARATION. U/T READINGS ARE SATISFACTORY SEE DRAWING.					
<b>RECOMMENDED REPAIRS</b>

BILGE POCKET AFT OF BHD (437)

RECOMMEND SHIP'S FORCE CLEAN AREA TO BARE METAL, PRESERVE AND PAINT. APPROXIMATELY 30 SF.					
SSPORT C221 POC: J. BRUCKNER (757) 396-4001 EXT 2186, TPOC: J. LaROCK (757) 490-5047					
<b>CSMP SUMMARY:</b> BILGE POCKET HAS RUST AND PAINT SEPARATION.				TEST# MRC 1102/1	
ROOT CAUSE/AMPLIFICATION: H1				STEP# 1,2,3,4 & 5	
SYSTEM LEVEL IMPACT:					
PART NO.	NOMENCLATURE		QTY	NSN	COST
1					
2					
3					
4					
5					
6					
FIRST CONTACT <b>TOMS</b>	RATE <b>MR 2</b>	SECOND CONTACT <b>BEARDEN</b>		RATE <b>HT 2</b>	PHONE
ASSESSOR / ACT / TECH ID# J. LaROCK/ T. ILGENFRITZ QED SYSTEMS INC.			TD	TL	LOGISTICIAN
					TSP
